INDIVIDUAL PROPERTY/DISTRICT
MARYLAND HISTORICAL TRUST
INTERNAL NR-ELIGIBILITY REVIEW FORM

Property/District Name: Paris Property Survey Number: CARR-236

CARR-236
Mt. Merino Farm
Raincliffe Road

Maryland Historical Trust State Historic Sites Inventory Form

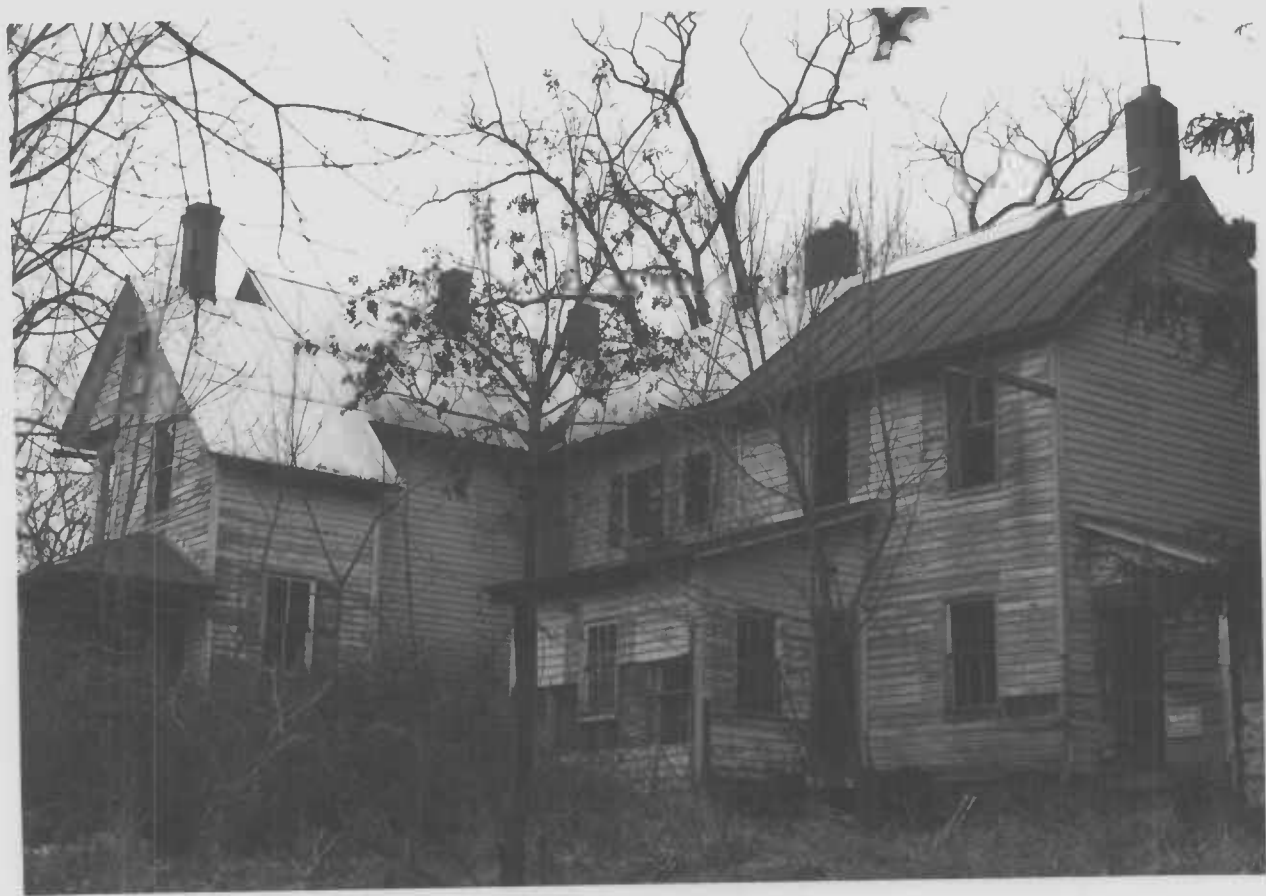
Mt. Merine Farm
Rancliffe Road
Lancaster County, Maryland
Photo. 1/11/1913. M. S. Sher

Neg. loc. Maryland Historical Trust
house - east - north elevation
3.

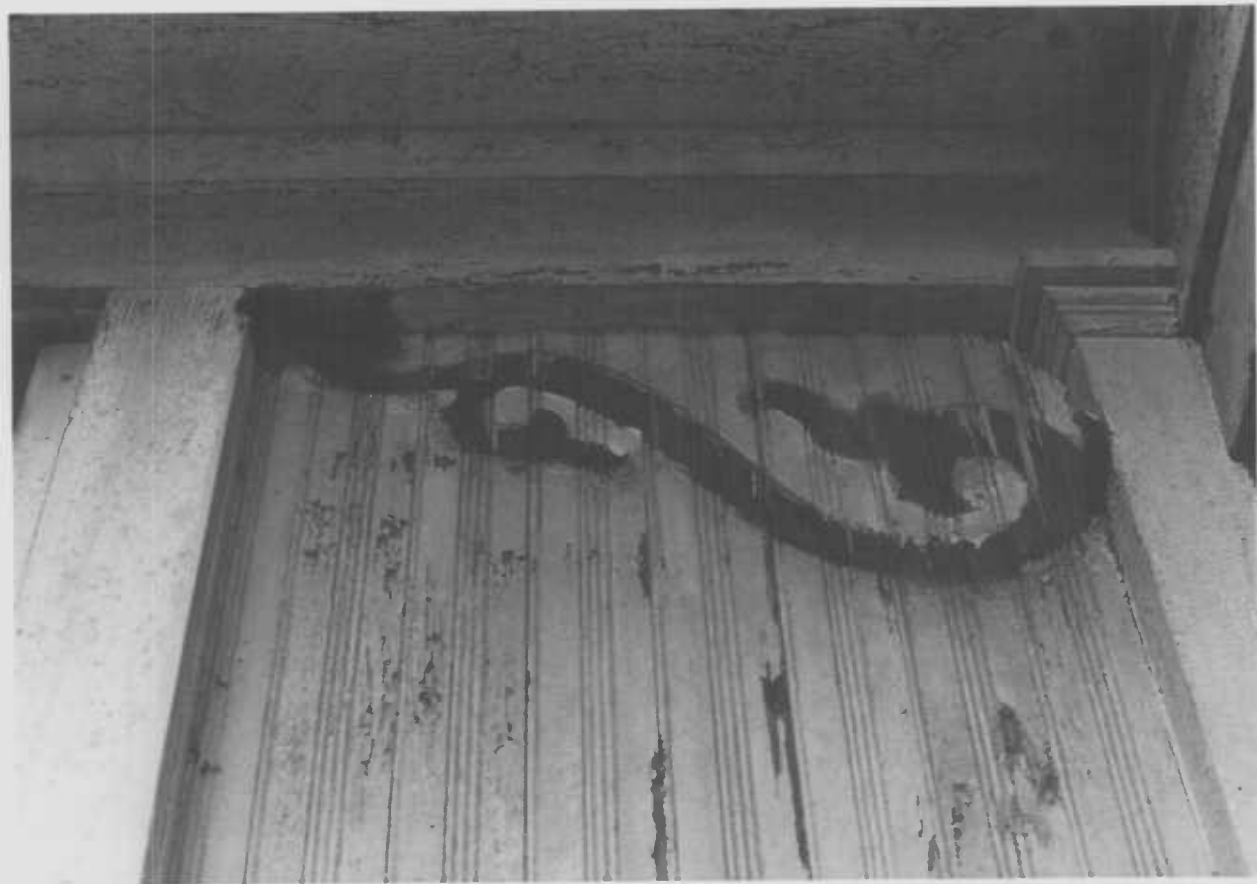
Mt. Merino Farm

House - ghost of bracket on west porch,
South elevation

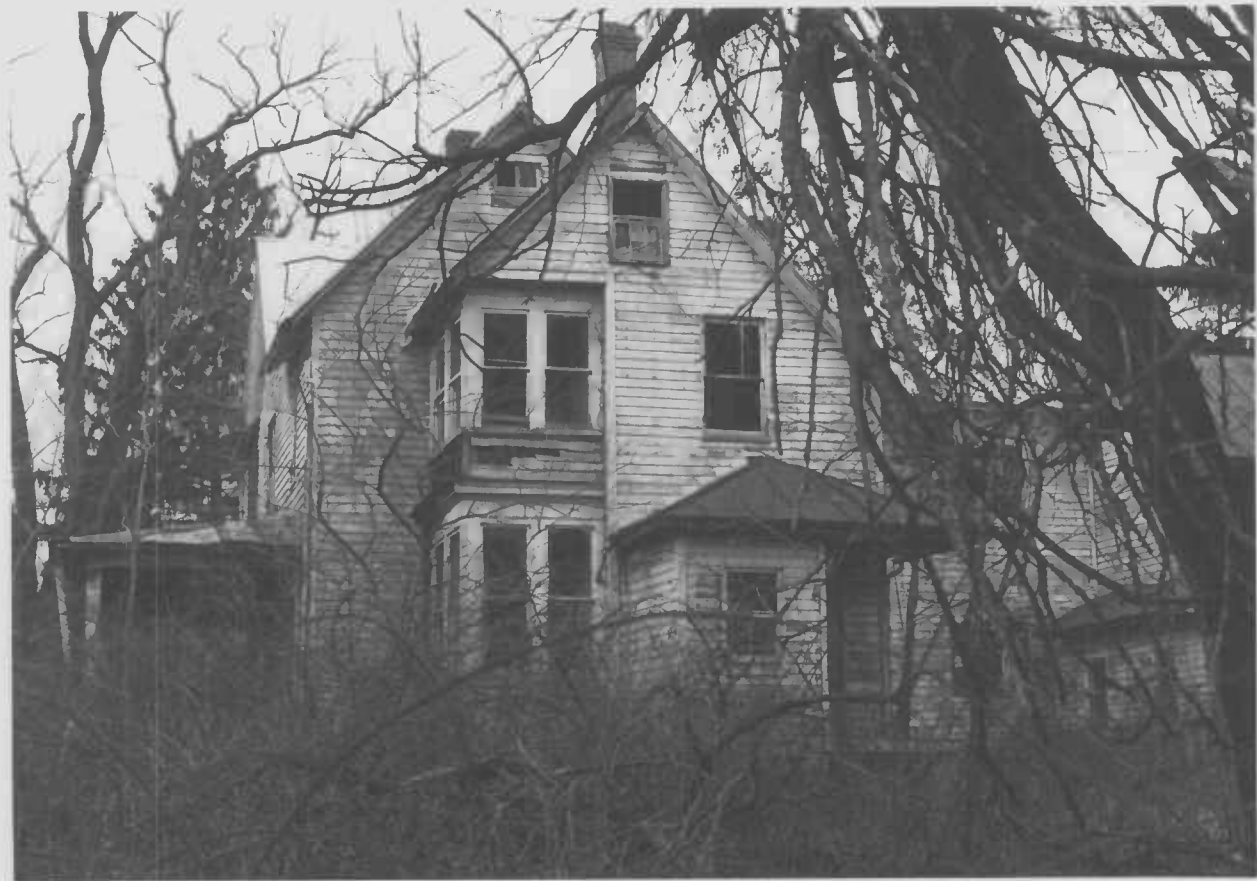
Mt. Merino Farm

house - east elevation
